## Barnstable bulkhead nears completion

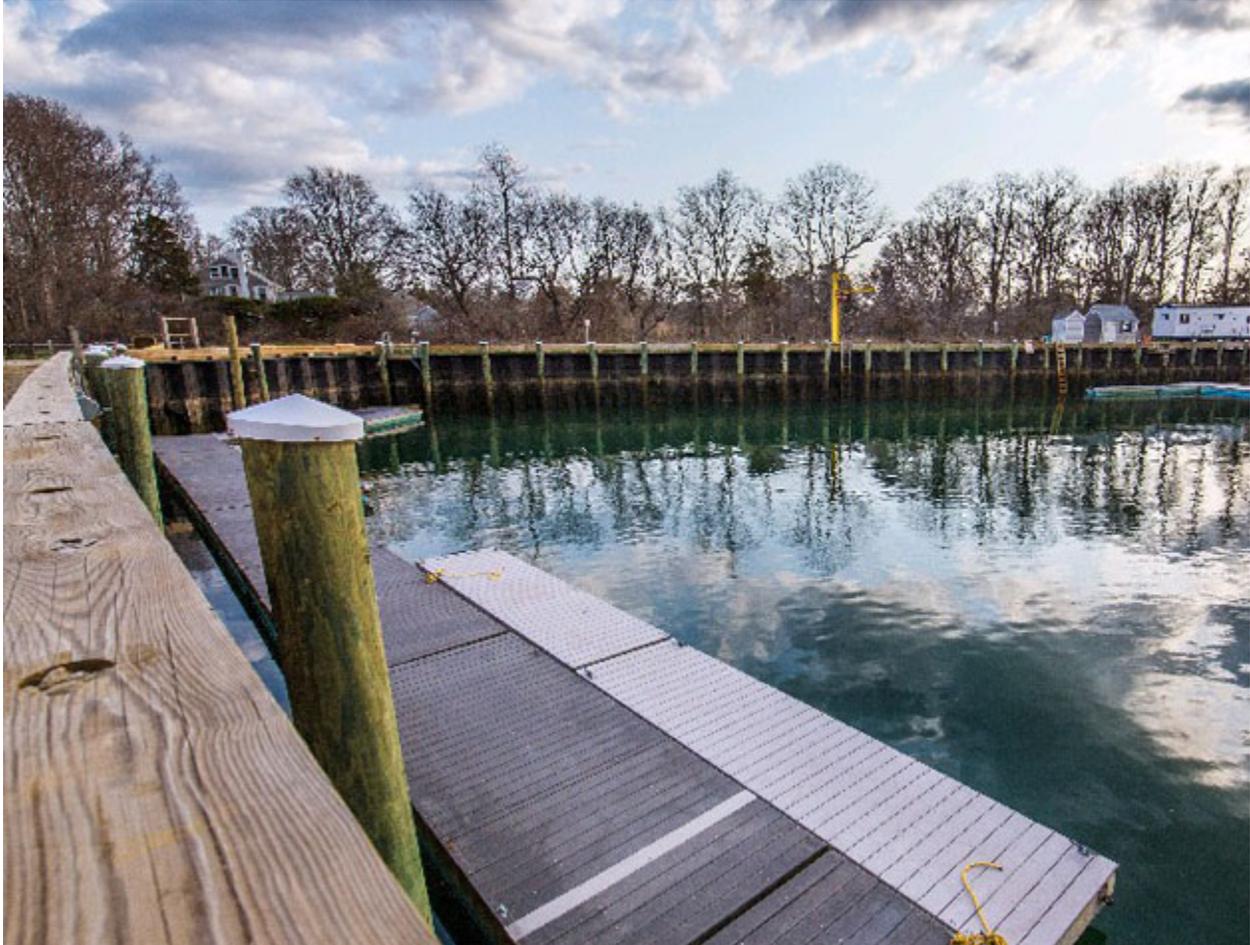
The bulkhead at Millway Marina/Barnstable Harbor. Photo by Alan Belanich
